Heritage and Us

Year 2, Issue 2, June 2013

CONTENTS

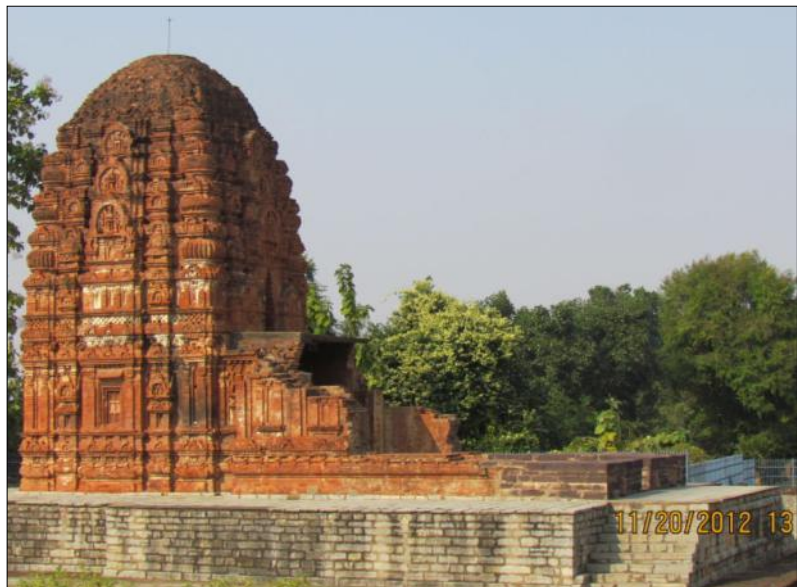
2. Lakshman Temple, Sirpur:
A brick structure

Percy Brown mentions, that the wood came to be substituted with lintels of stone, and a phase then ensued when brick buildings with stone stressing found favour. The use of stone in the otherwise brick structure can be seen in the Lakshman temple as well, where the pillars of the *mandapa* now in ruins, the door-frame of the sanctum and the base platform are made of stone (Kramrisch 1986: 102). Lakshman temple is one of the loveliest brick temples in the country (fig. 2). Its construction was the turning point in the brick temple architecture according to Percy Brown.

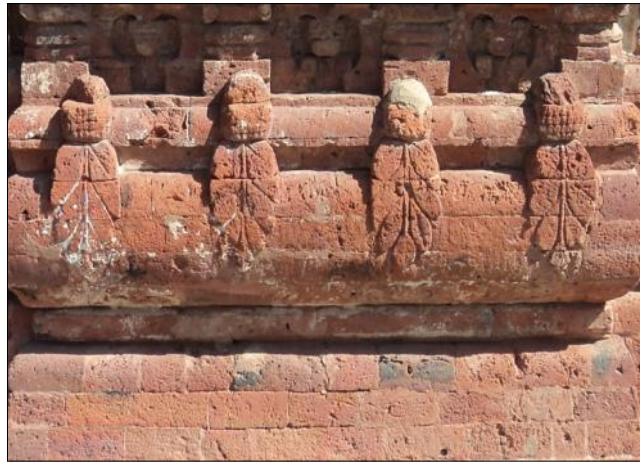
the joints to be kept particularly fine (Brown 1956: 42; Tomory 1982: 90). Their appearance therefore is that of a solid mass without the patchy effect, a characteristic of brick work (fig. 9).

9. Lakshman Temple, Sirpur:
Carvings of *ashoka* leaves in brick work

Lastly, the ornamentation was chiselled out of the brick work after the walls were built, and the carvings carried over the joints as if the whole work is made in one piece. The average size of the bricks is 42.6x22.5x7.5 cm and the surfaces of each have been laboriously rubbed down to a smooth finish, thus enabling

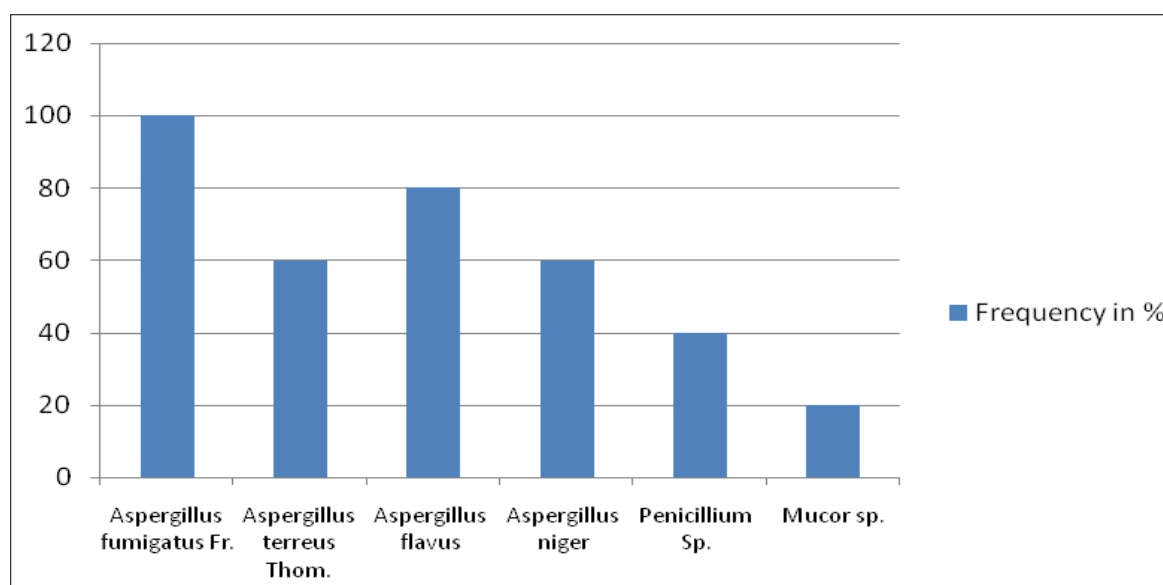
Graph showing frequency of fungal species in Surya temple

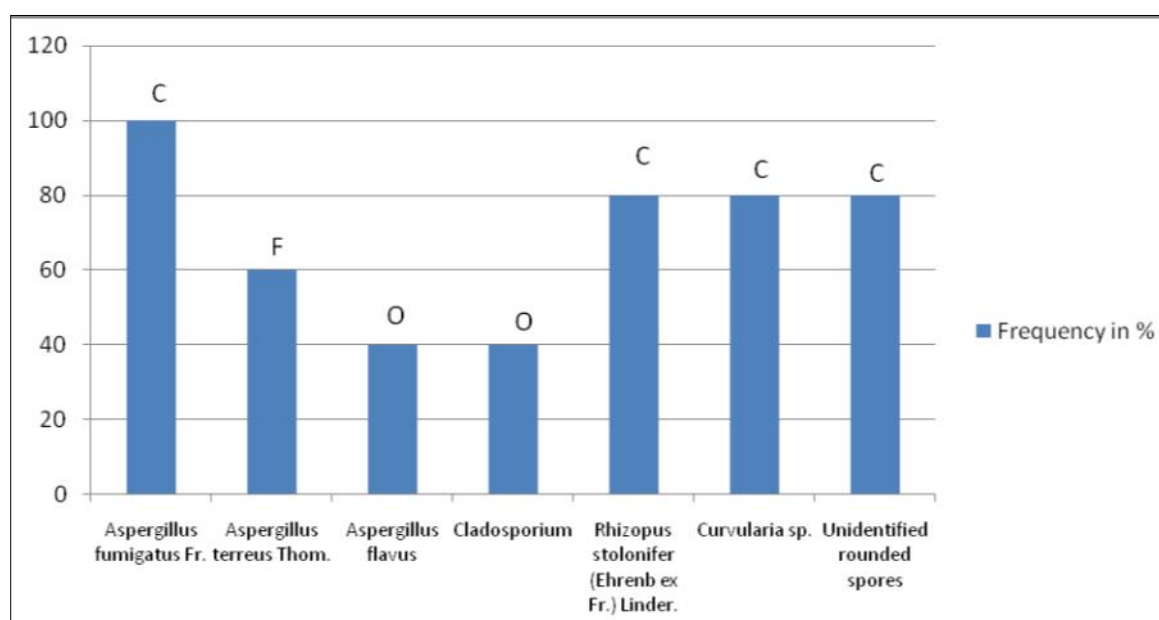
Graph showing frequency of fungal species in Mahadeva temple

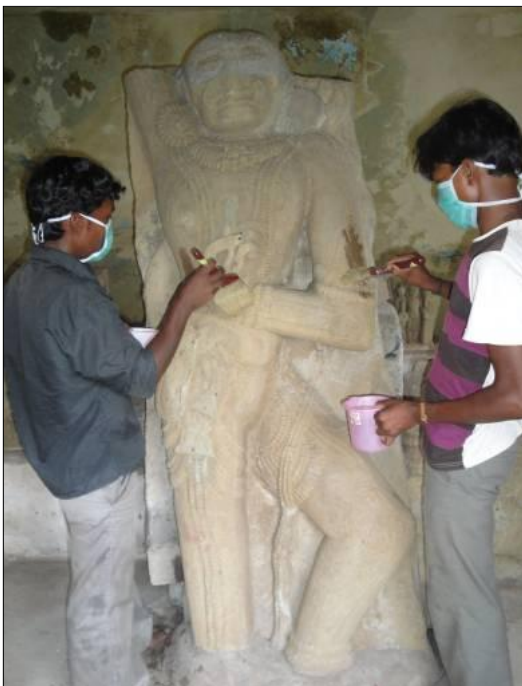
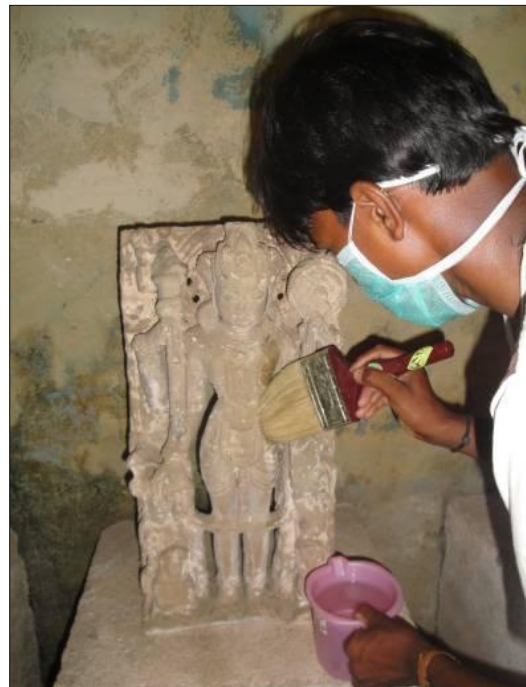
44-45. Mahadeva and Surya Temple, Narayanpur, Chhattisgarh: Application of ethyl silicate base coating on the sculptures

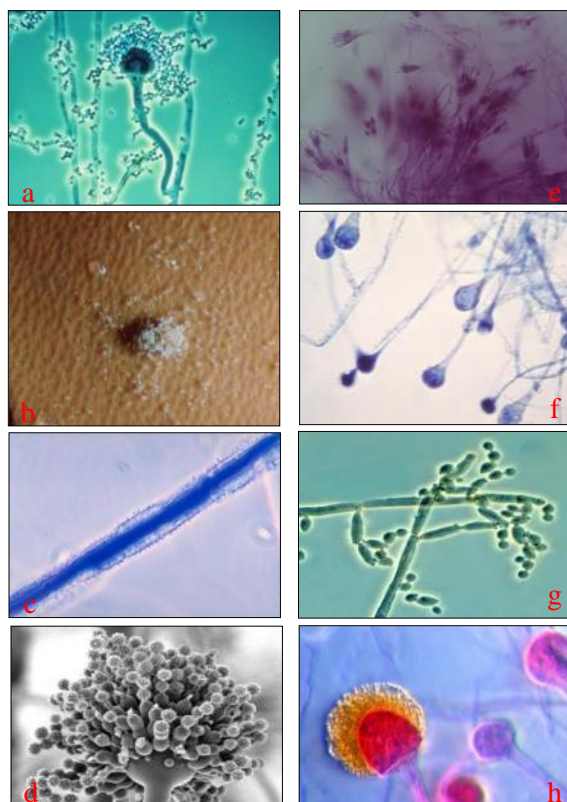
Thirteen species of fungi were detected in the biofilm collected from both the monuments (as shown in table 2-3) (fig. 46a-h). Fungal species was found in the various location of the stone monument in a biofilm where their effect on the stone substrate led to the deterioration of the monument. These communities forming thick biofilms produced intense pigmentation varying from dark green to dark red which altered the aesthetic appearance of the stone. *Aspergillus fumigatus* Fr., *Aspergillus terreus* Thom. and *Aspergillus flavus* fungal species are common on stone in the monument. The number of micro-organisms increased from late pre-monsoon to monsoon. In summer they turned as dry black biomass but become abundant once again with rains. Hence if this dry biomass could be

46a-h. Fungal species in the biofilm of stone monuments - a) *Aspergillus fumigatus* Fr; b) *Aspergillus terreus* Thom.; c) *Aspergillus flavus*; d) *Aspergillus niger*; e) *Penicillium* Sp; f) *Mucor* sp; g) *Cladosporium*; h) *Rhizopus stolonifer*

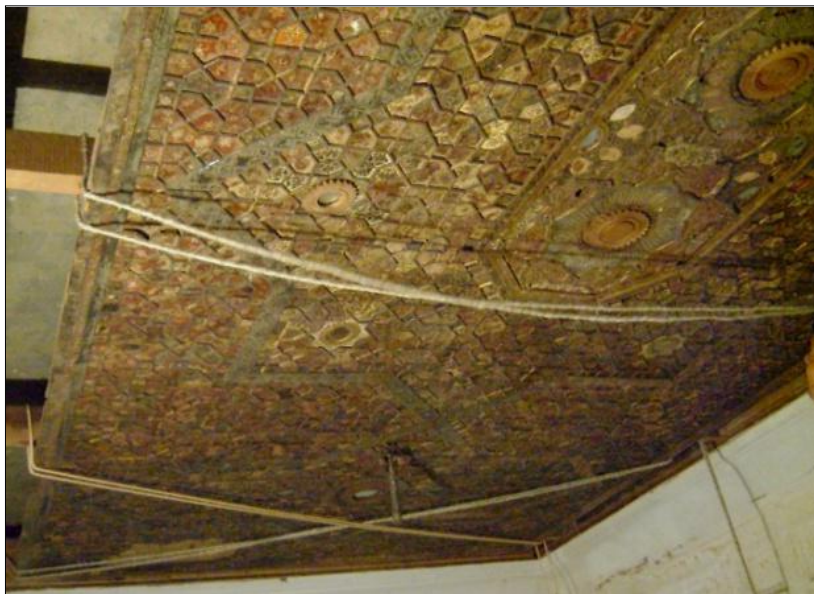
49. Maharaja Ranjit Singh Summer Palace Museum, Amritsar:
Dismantling of Ceiling

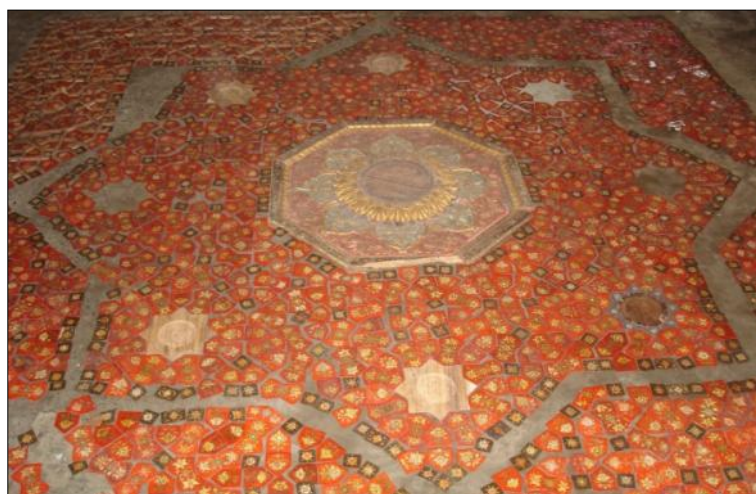
50. Maharaja Ranjit Singh Summer Palace Museum, Amritsar:
Ceiling assembled on ground after dismantling

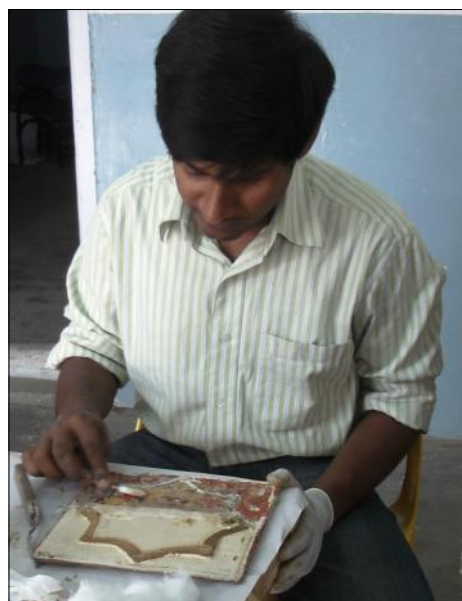
51. Chemical Cleaning of surface

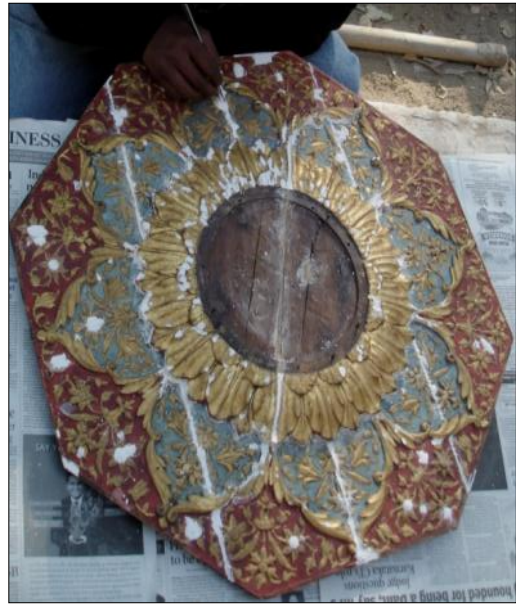
53. Filling using the mixture of putty powder

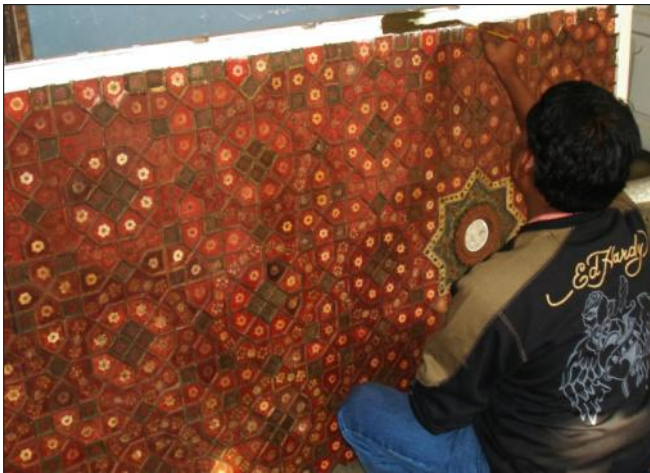
54. Retouching being done by an art conservator

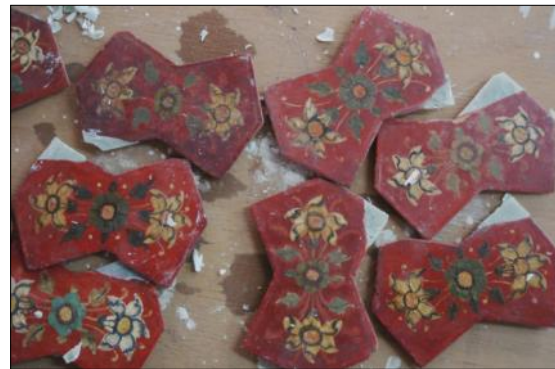
55. Regeneration of missing parts

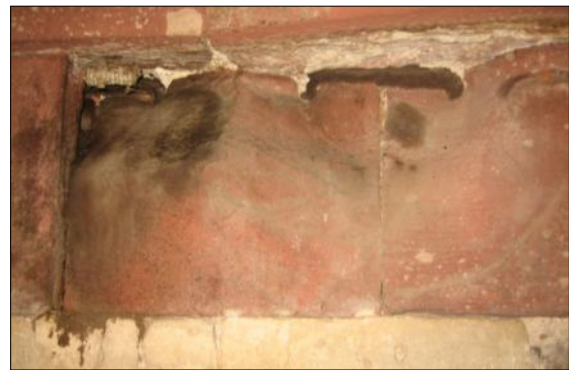
57. Muhammad Shah's Tomb, Lodi Garden, Delhi: Damages in sandstone ashlar blocks due to rusted iron member

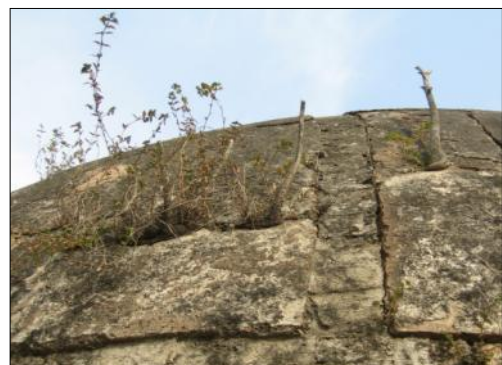
58. Bara Lao Ka Gumbad, Vasant Vihar, Delhi: Vegetation growth on monument

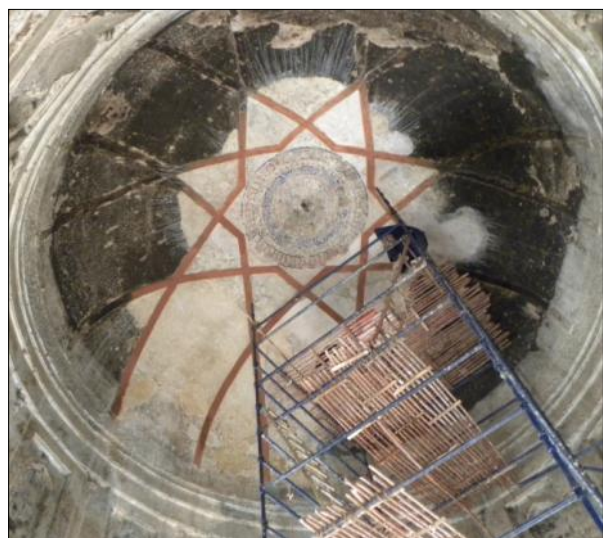
59. Bara Lao Ka Gumbad, Vasant Vihar, Delhi:
Algae/ Lichens growth due to dampness

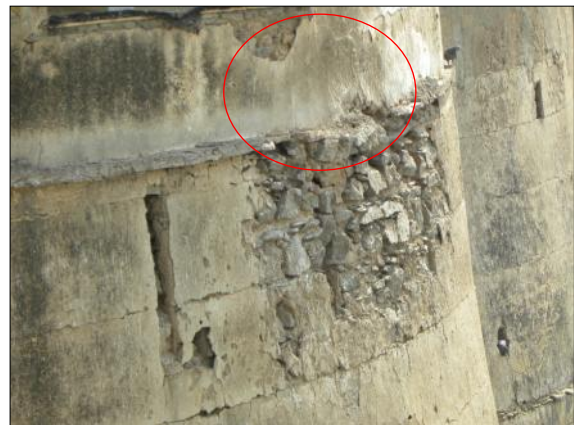
61. Lachmangarh Fort, Rajasthan: Piling of plaster on fortification due to exposure to open weather

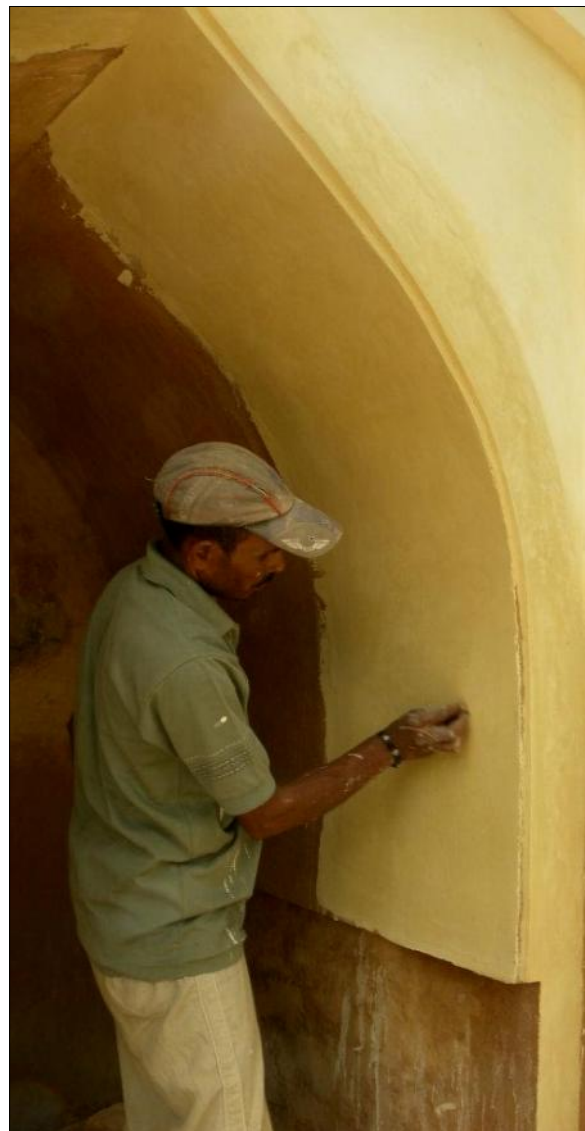
63. Mosque of Darwesh Shah, New Delhi:
Finishing and smoothening of plastered surface by
application of lime punning over it

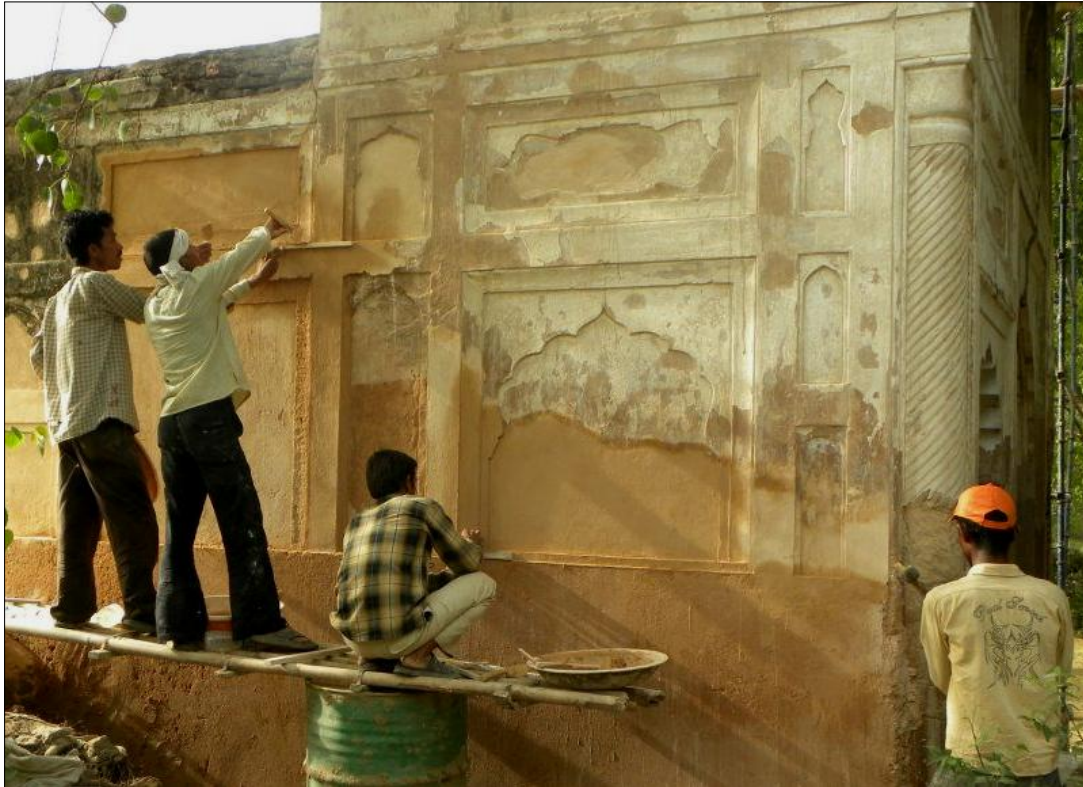
64. Gateway, New Delhi: Restoration of missing ornamental lime plaster

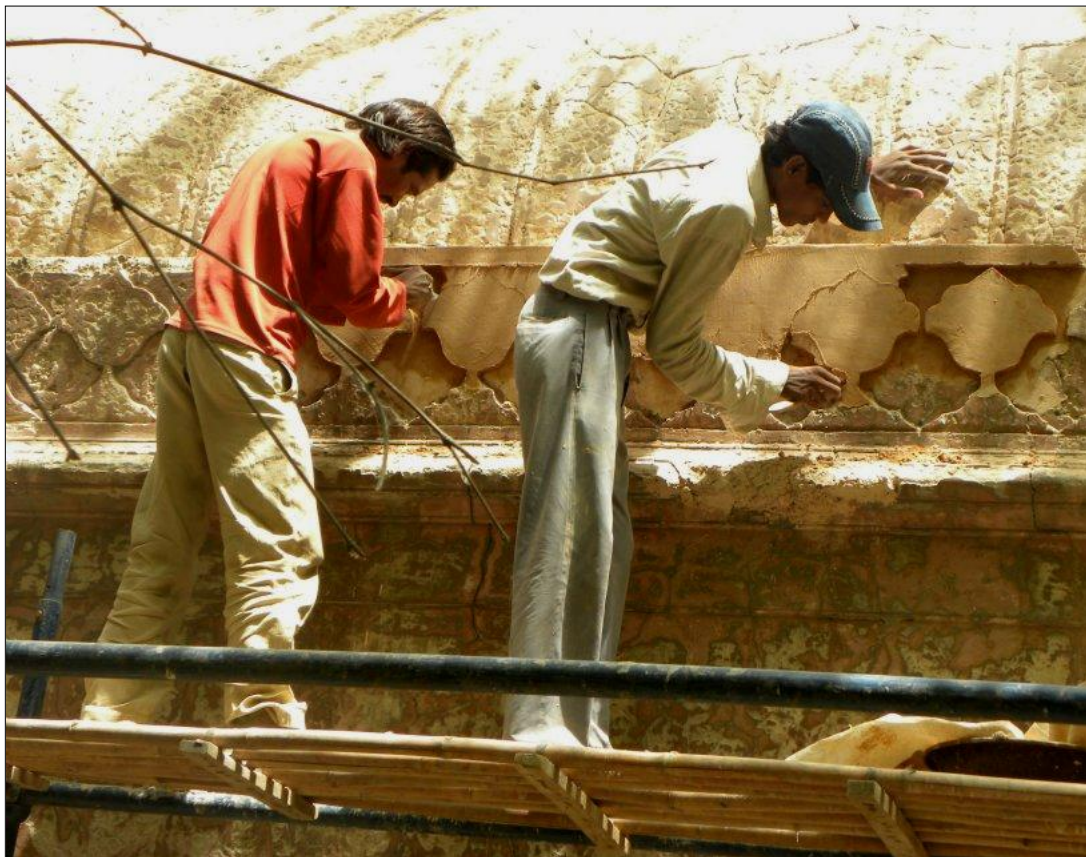
65. Unknown Mosque, New Delhi: Restoration of *kangoora* design using lime mortar
